**AFFDL-TR-78-175**  
**Volume III**

**EFFECT OF MULTIAXIAL LOADING  
ON CRACK GROWTH  
Volume III - Compilation of Interferometry Photographs**

*NORTHROP CORPORATION  
AIRCRAFT GROUP  
HAWTHORNE, CALIFORNIA 90250*

*December 1978*

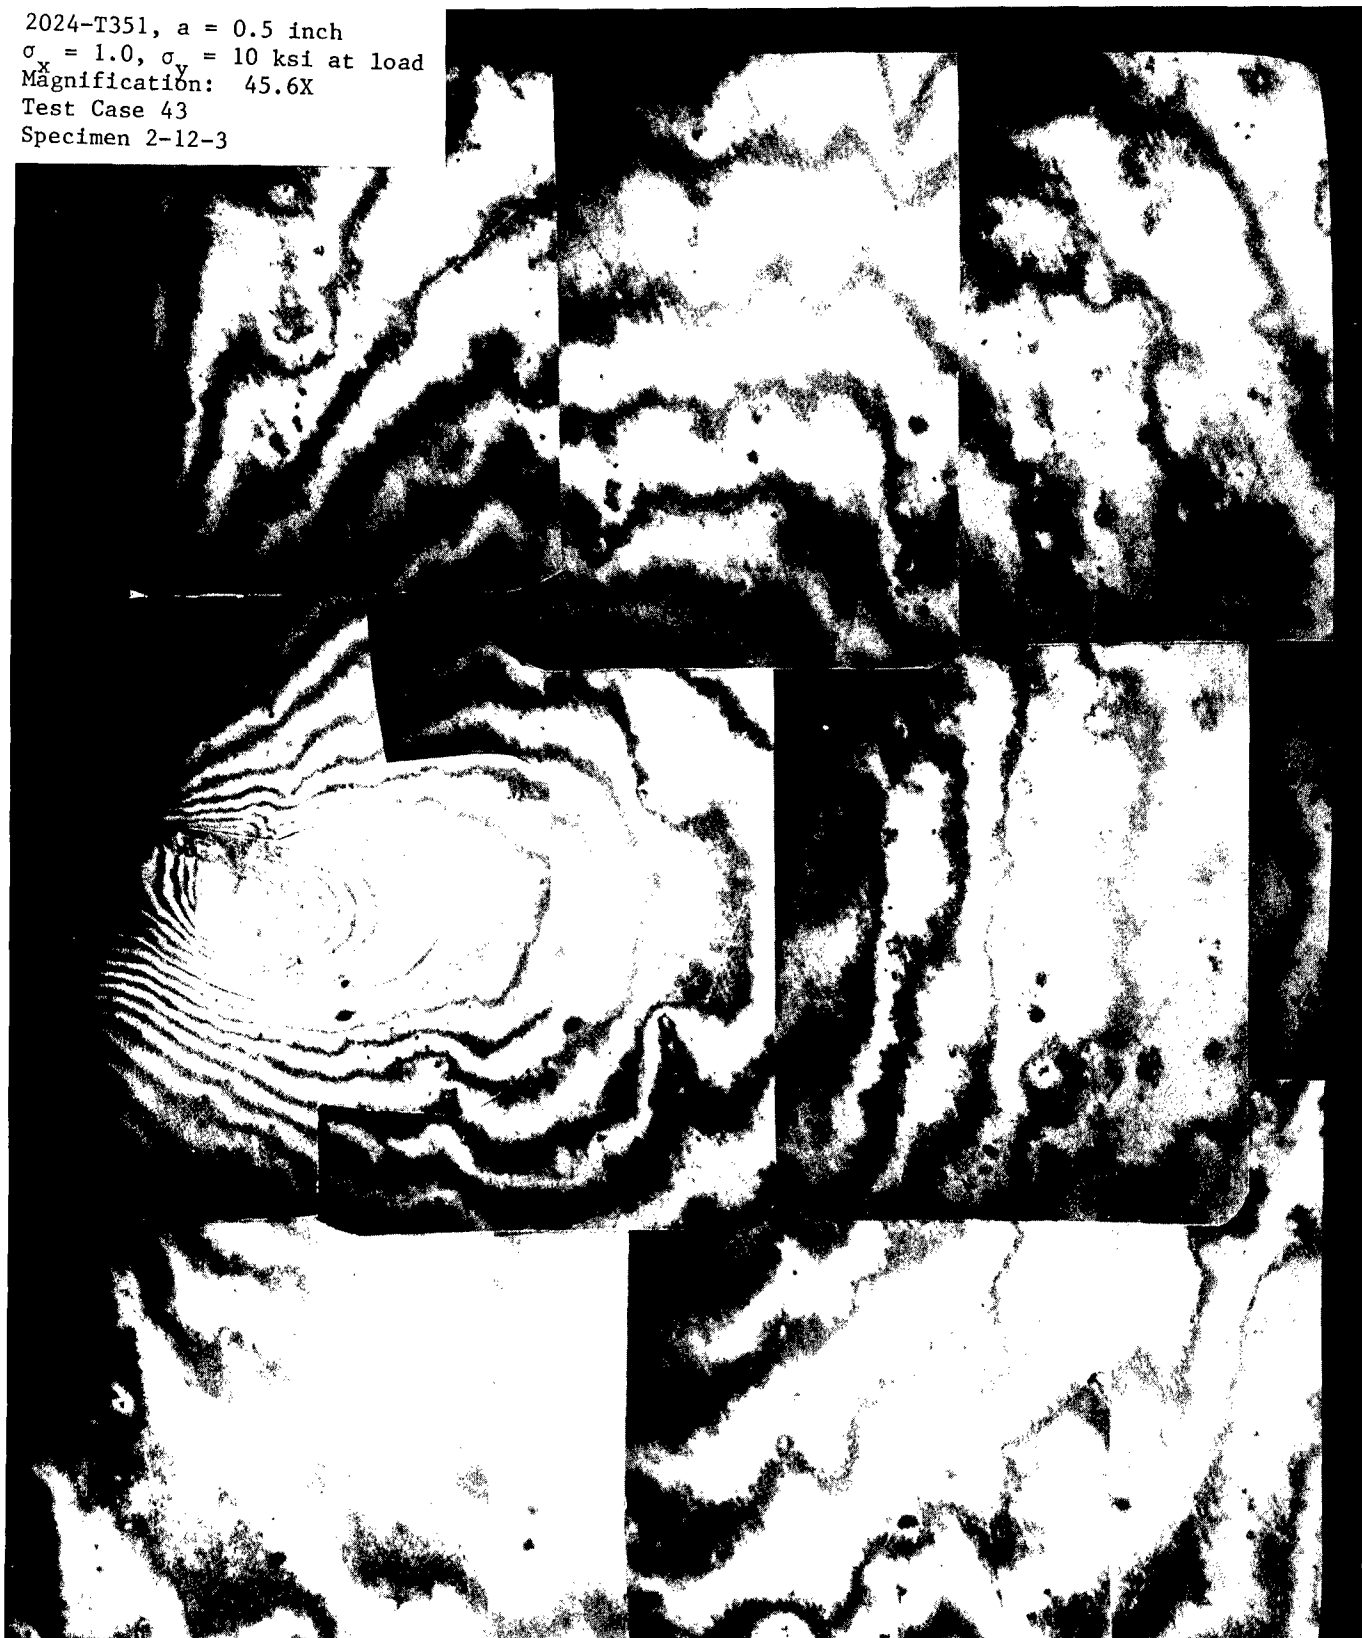
Figure 144. Interferometry Photograph of an Unloaded Crack in a 2024-T351 Specimen

2024-T351,  $a = 0.5$  inch  
 $\sigma_x = 1.0$ ,  $\sigma_y = 10$  ksi at load  
Magnification: 45.6X  
Test Case 43  
Specimen 2-12-3

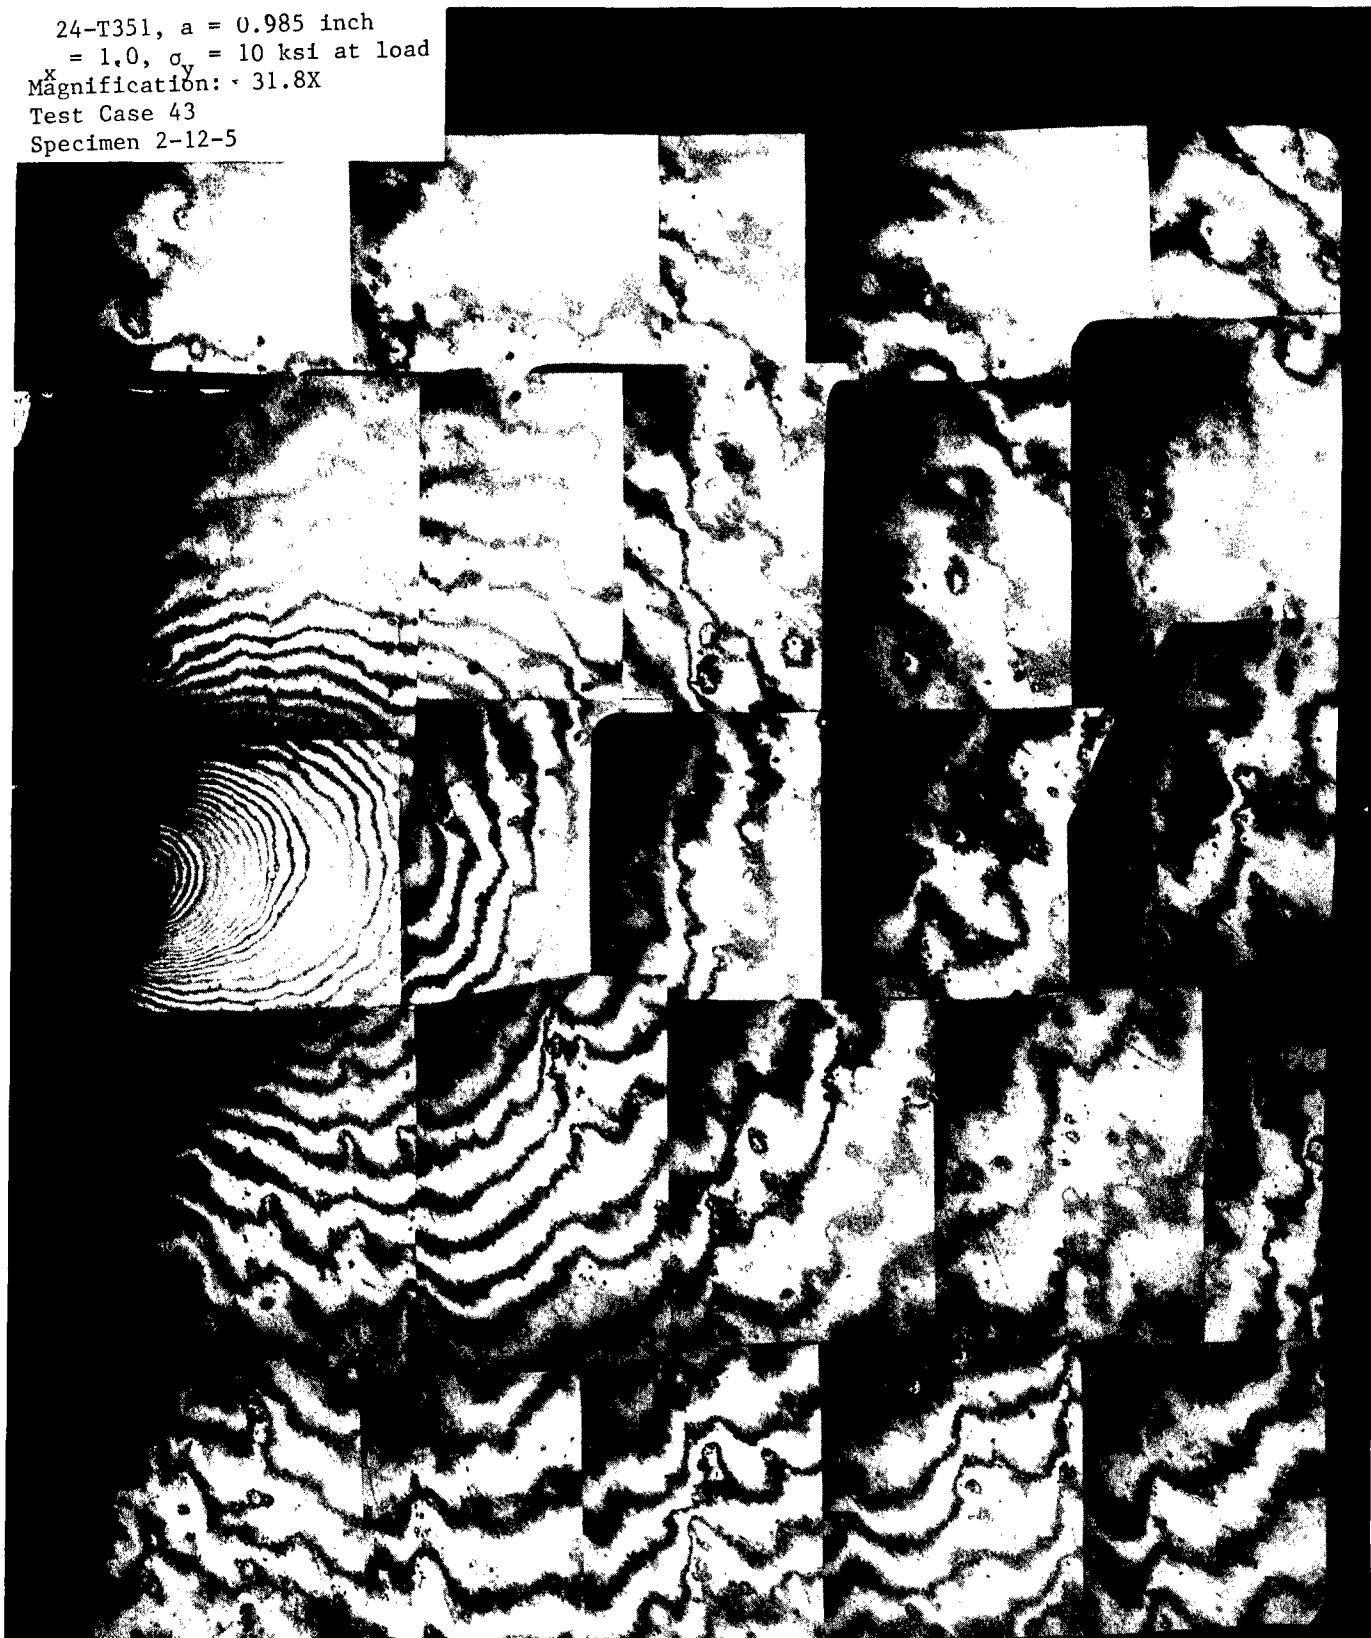
Figure 146. Interferometry Photograph of an Unloaded Crack  
in a 2024-T351 Specimen

24-T351,  $a = 0.985$  inch  
 $\sigma_x = 1.0$ ,  $\sigma_y = 10$  ksi at load  
Magnification:  $\times 31.8X$   
Test Case 43  
Specimen 2-12-5

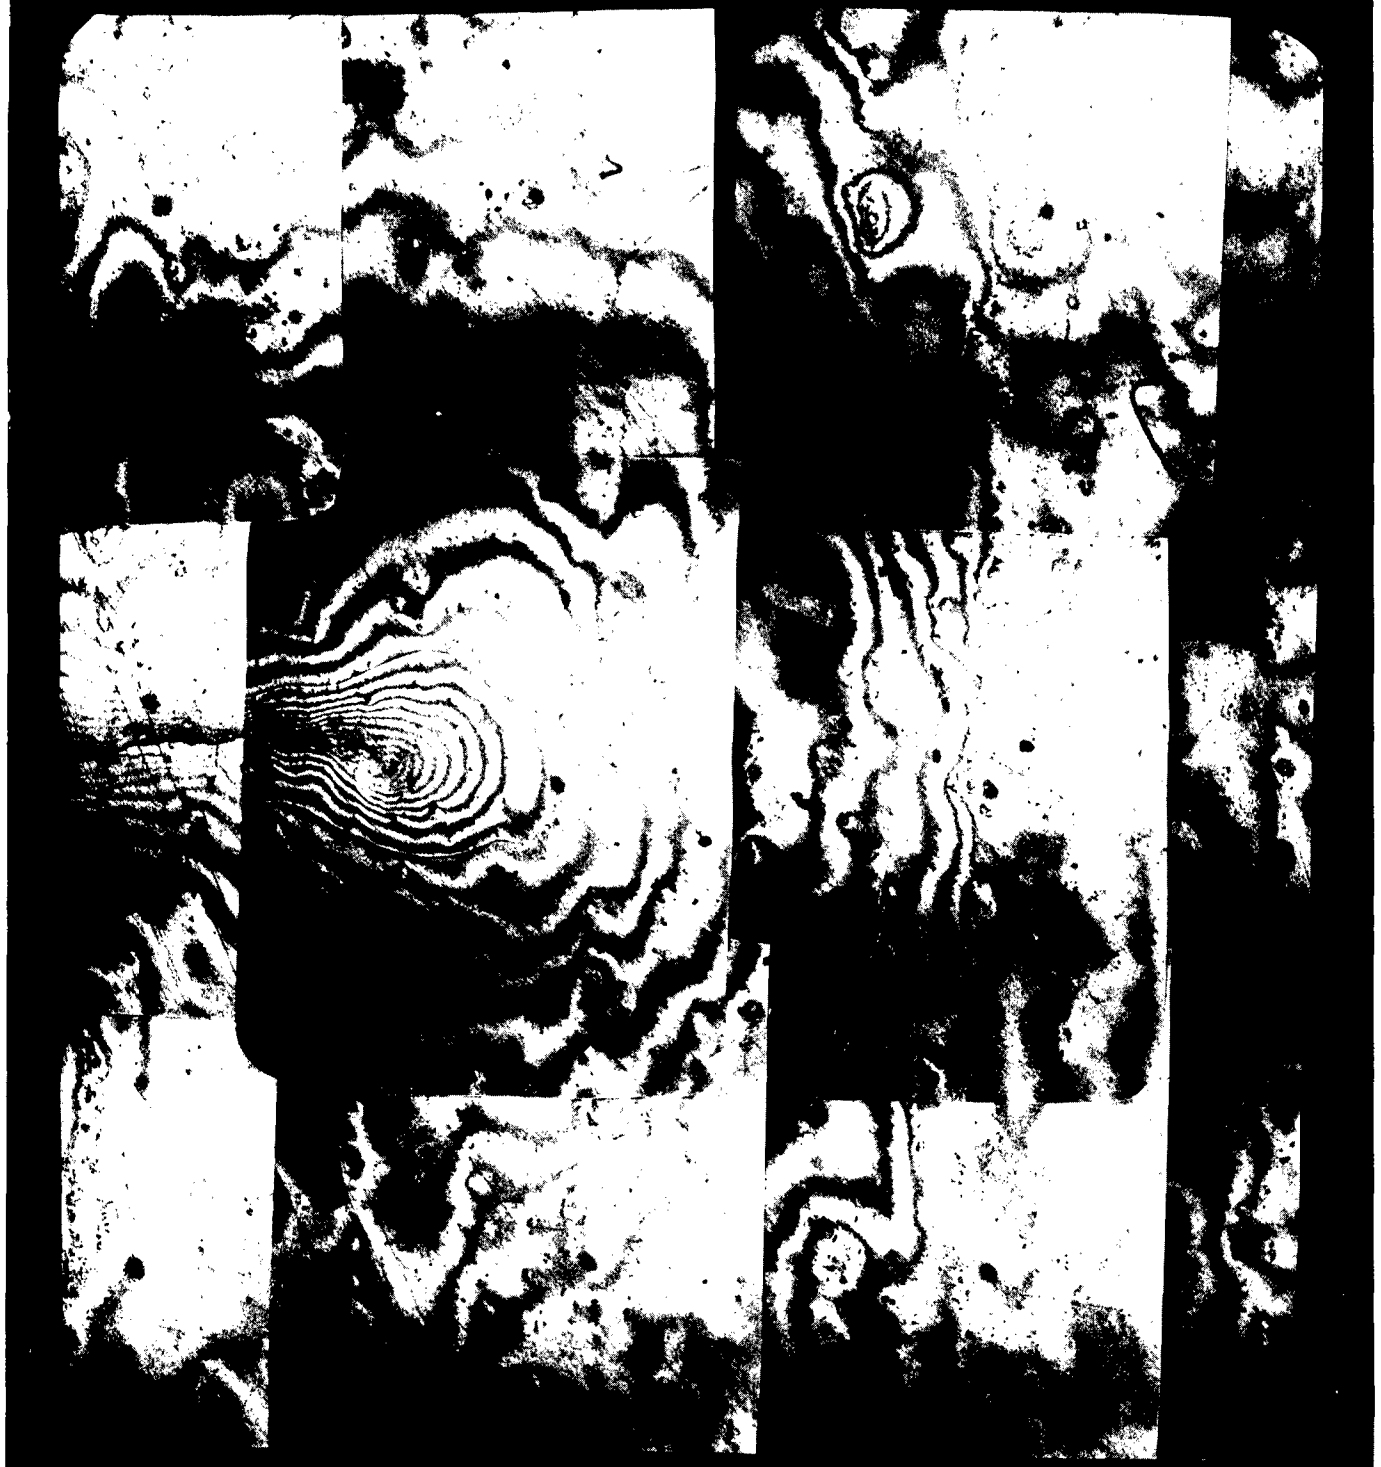
Figure 148. Interferometry Photograph of an Unloaded Crack in a 7075-T7351 Specimen

7075-T7351,  $a = 0.5$  inch  
 $\sigma_x = -8.4$ ,  $\sigma_y = 12$  ksi at load  
Magnification: 45.2X  
Test Case 44  
Specimen 2-35-2

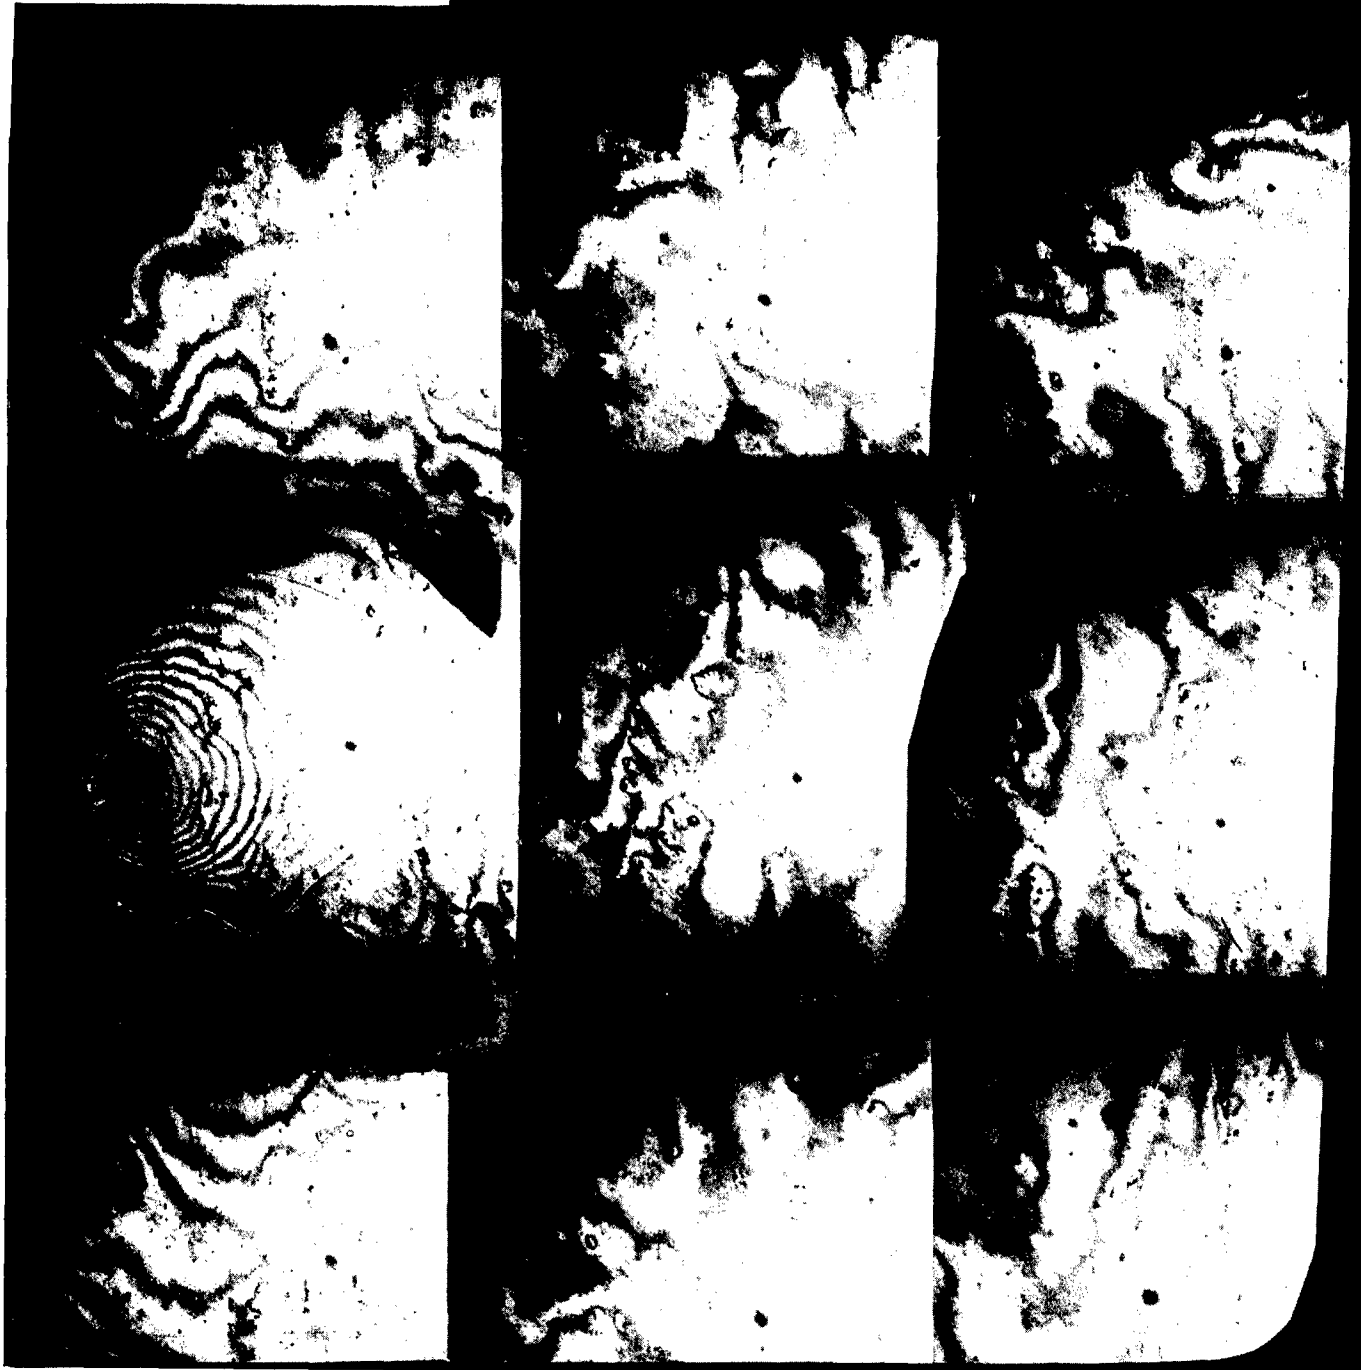
Figure 151. Interferometry Photograph of an Unloaded Crack in a 7075-T7351 Specimen

7075-T7351,  $a = 1.02$  inch  
 $\sigma_x = -8.4$ ,  $\sigma_y = 12$  ksi at load  
Magnification: 44.7X  
Test Case 44  
Specimen 2-35-4

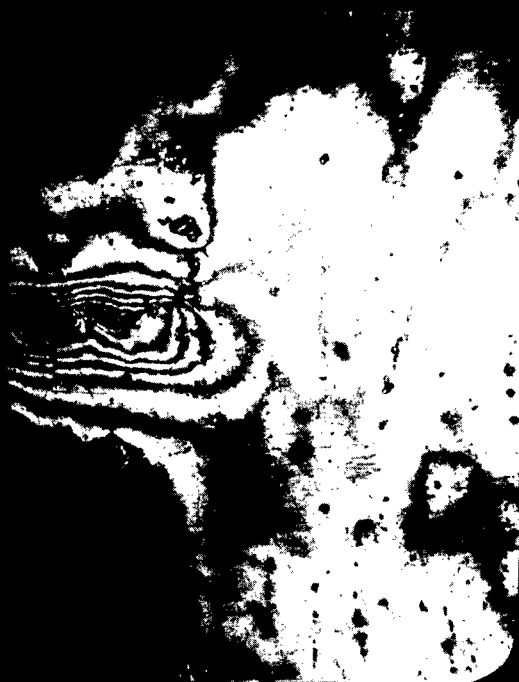
Figure 152. Interferometry Photograph of a Loaded Crack in a 7075-T7351 Specimen

2024-T351,  $a = 0.25$  inch  
 $\sigma_x = 0.5$ ,  $\sigma_y = 10$  ksi unloaded  
Magnification: 46.8X  
Test Case 45  
Specimen 2-7-1

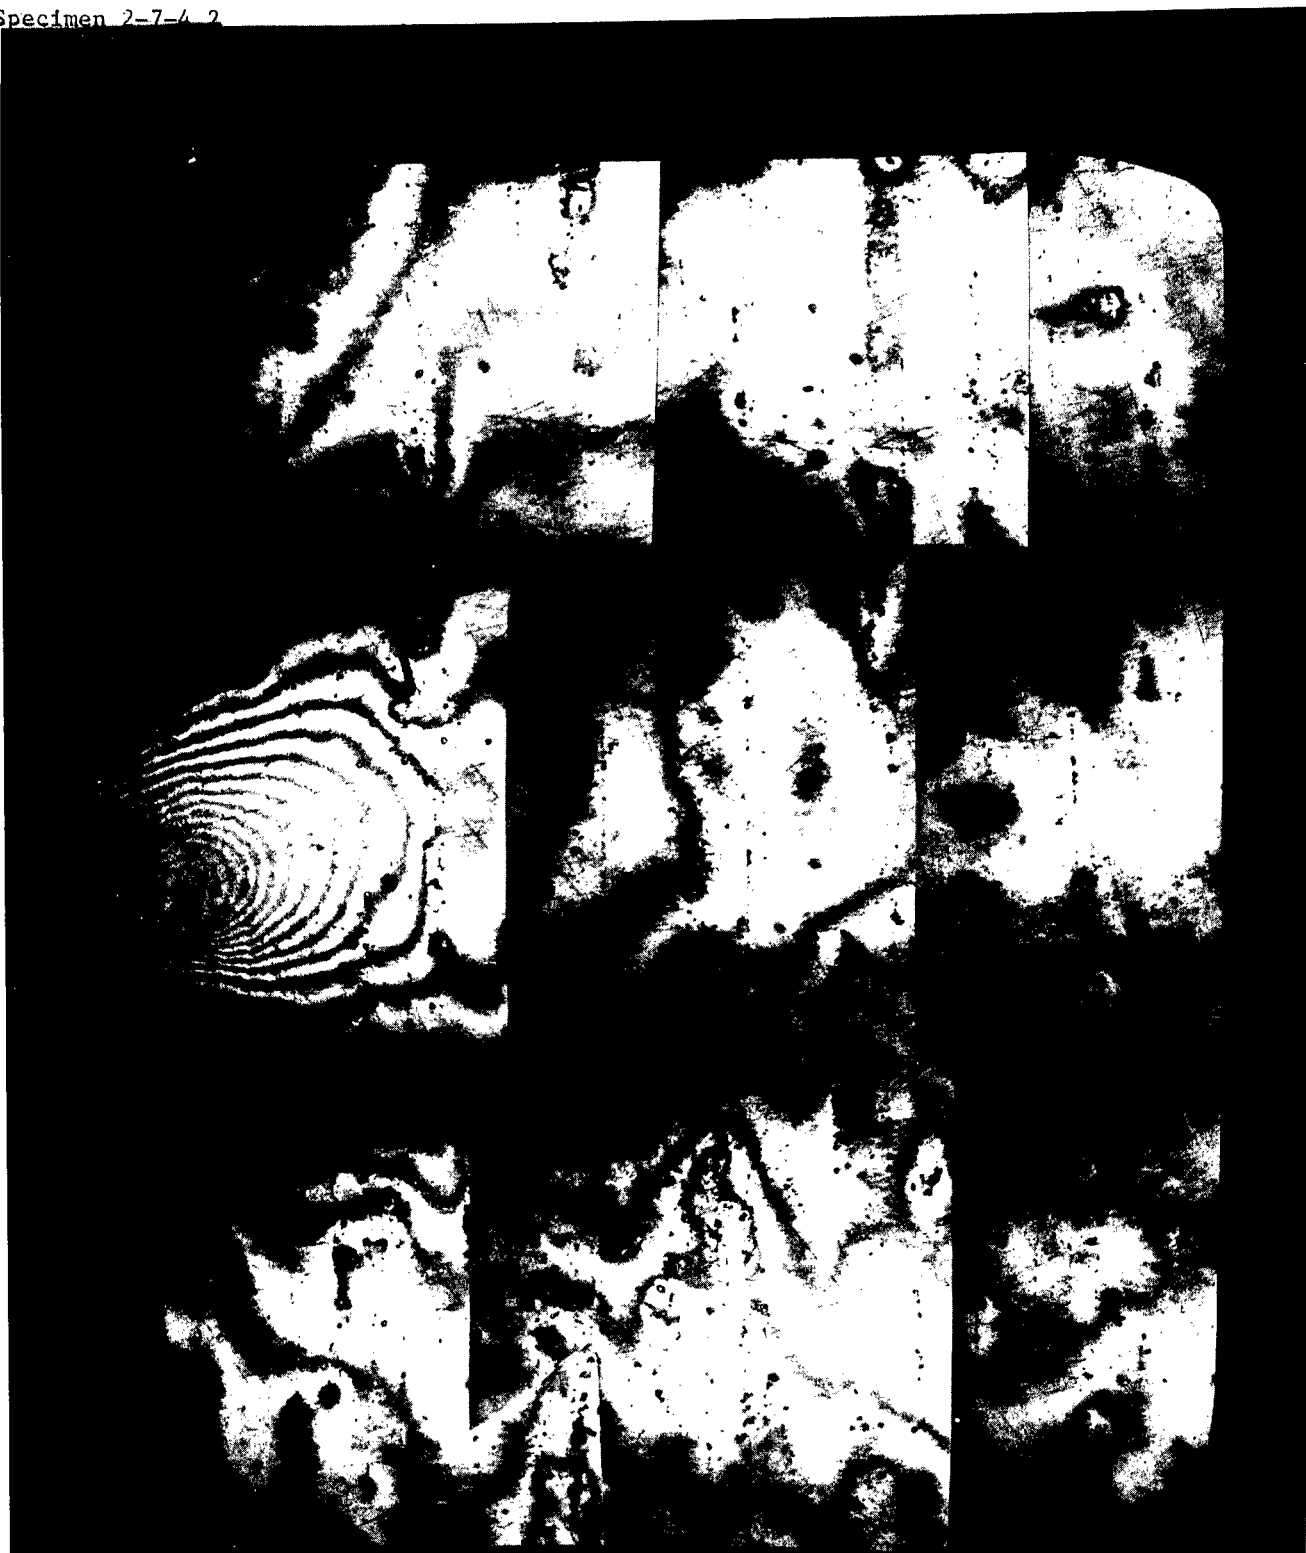
Figure 156. Interferometry Photograph of a Loaded Crack in a 2024-T351 Specimen

2024-T351,  $a = 0.495$  inch  
 $\sigma_x = 0.5$ ,  $\sigma_y = 10$  ksi at load  
Magnification: 44.0X  
Test Case 45  
Specimen 2-7-4-2

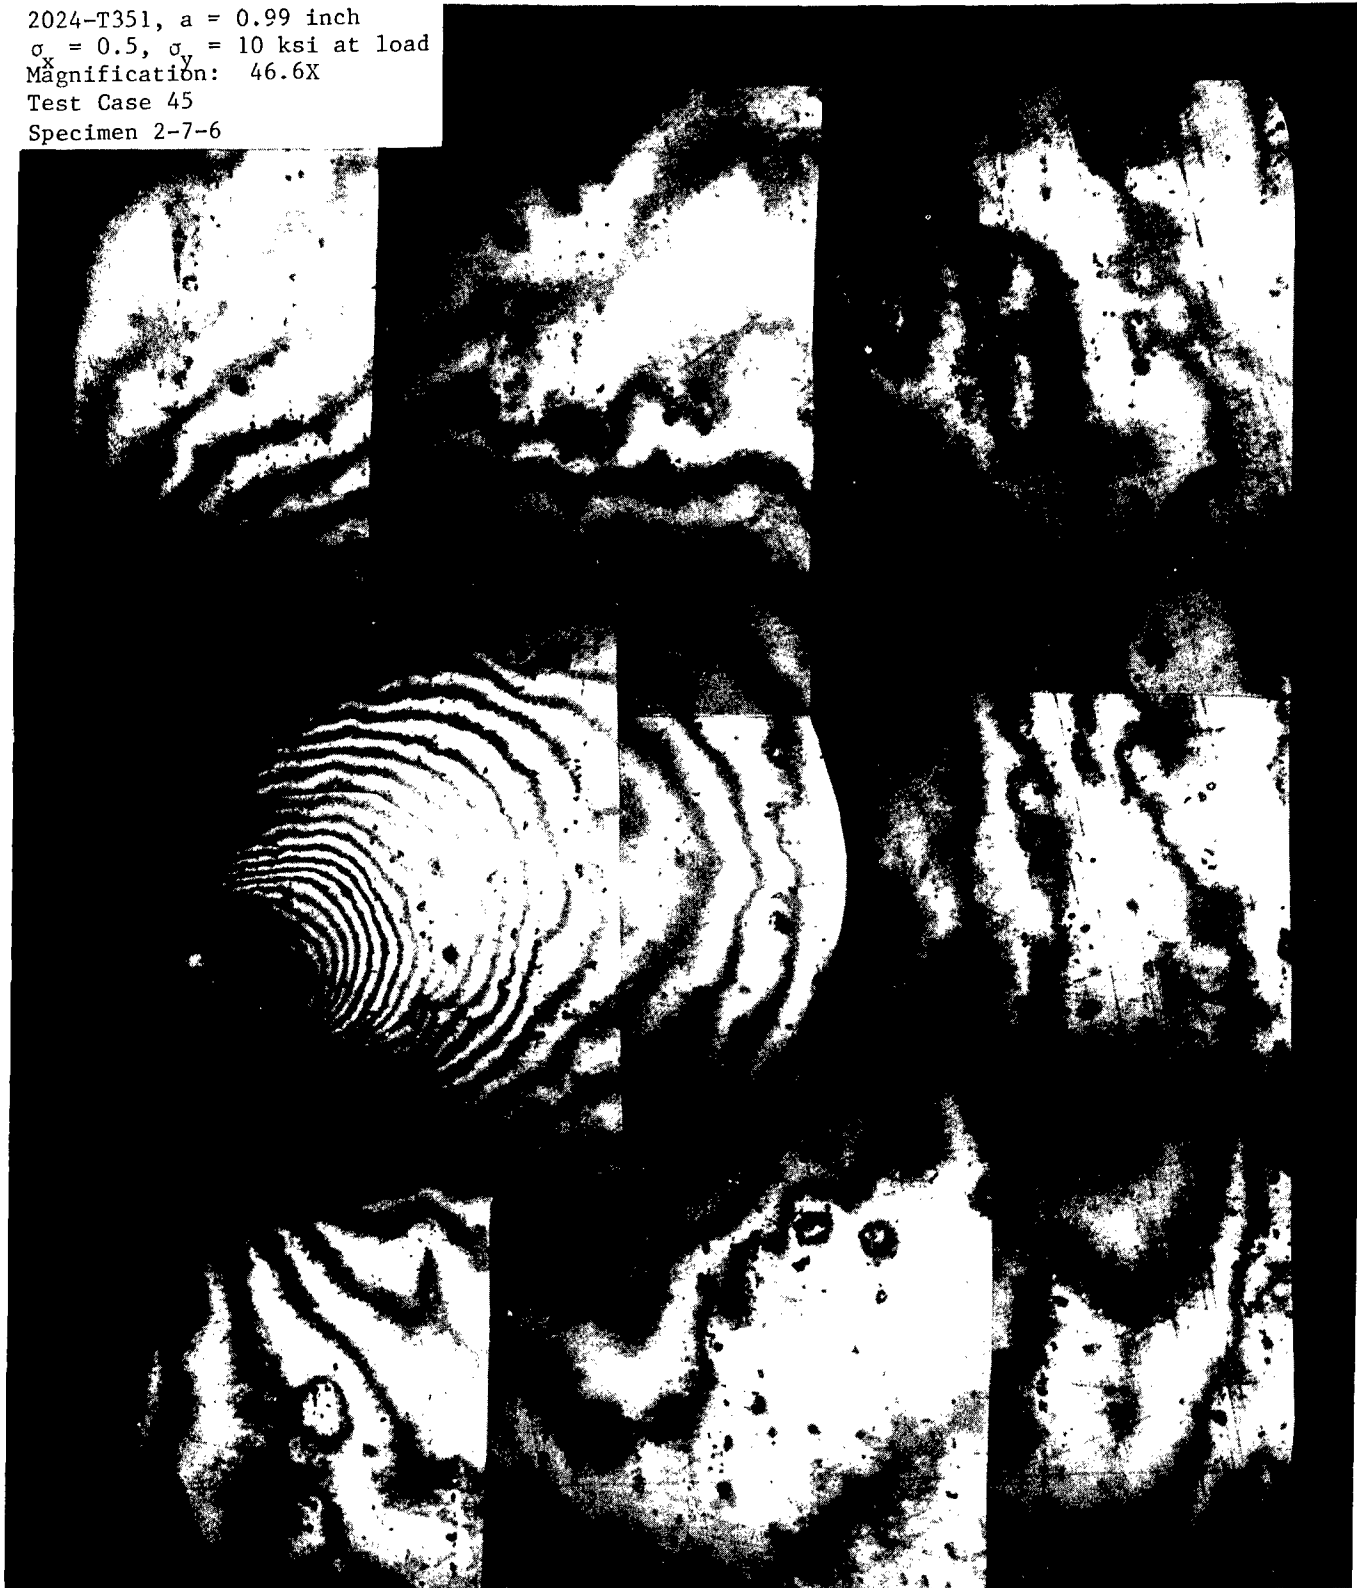
Figure 158. Interferometry Photograph of an Unloaded Crack in a 2024-T351 Specimen

2024-T351,  $a = 0.99$  inch  
 $\sigma_x = 0.5$ ,  $\sigma_y = 10$  ksi at load  
Magnification: 46.6X  
Test Case 45  
Specimen 2-7-6

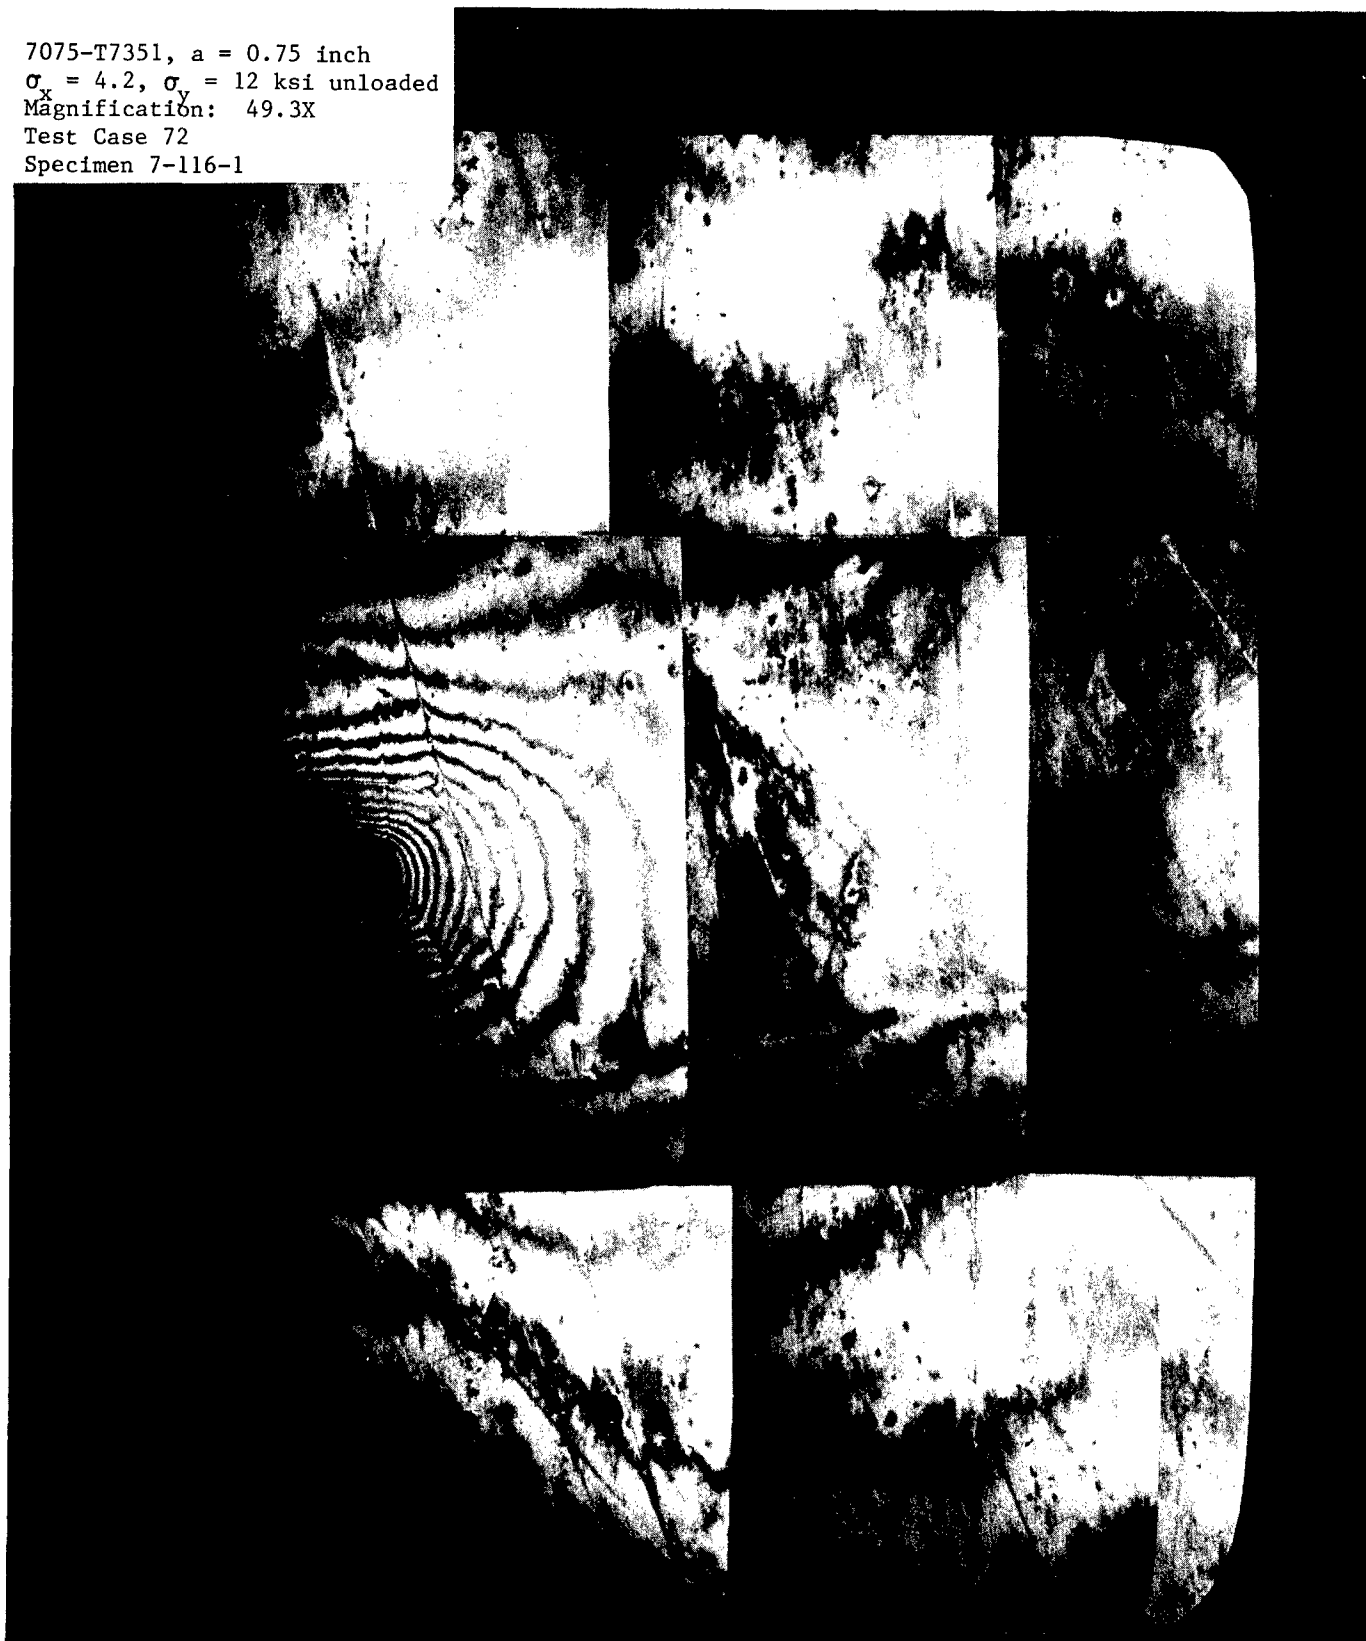
Figure 163. Interferometry Photograph of a Loaded Crack in a  
7075-T7351 Specimen

7075-T7351,  $a = 0.75$  inch  
 $\sigma_x = 4.2$ ,  $\sigma_y = 12$  ksi unloaded  
Magnification: 49.3X  
Test Case 72  
Specimen 7-116-1
